2020

REPORT

Hunter Lake: State of the Lake Report to the Conover Town Lakes Committee June 2020

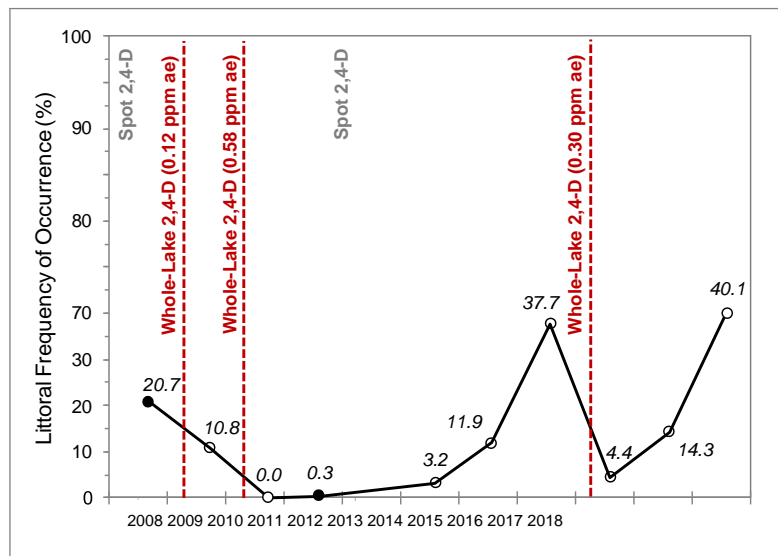
Figure 2.0-1. Littoral occurrence of EWM from South Twin Lake from 2008-2018. Open circle represents a statistically valid change from previous survey (Chi-square $\alpha = 0.05$).

exceed 12% littoral frequency of occurrence (LFOO). This threshold was based upon coupling the South Twin Lake point-intercept data at these levels with the Late-Summer EWM Mapping Survey data. When EWM populations exceeded this approximate benchmark in the past, *highly dominant* and *surface matted* conditions started becoming apparent.

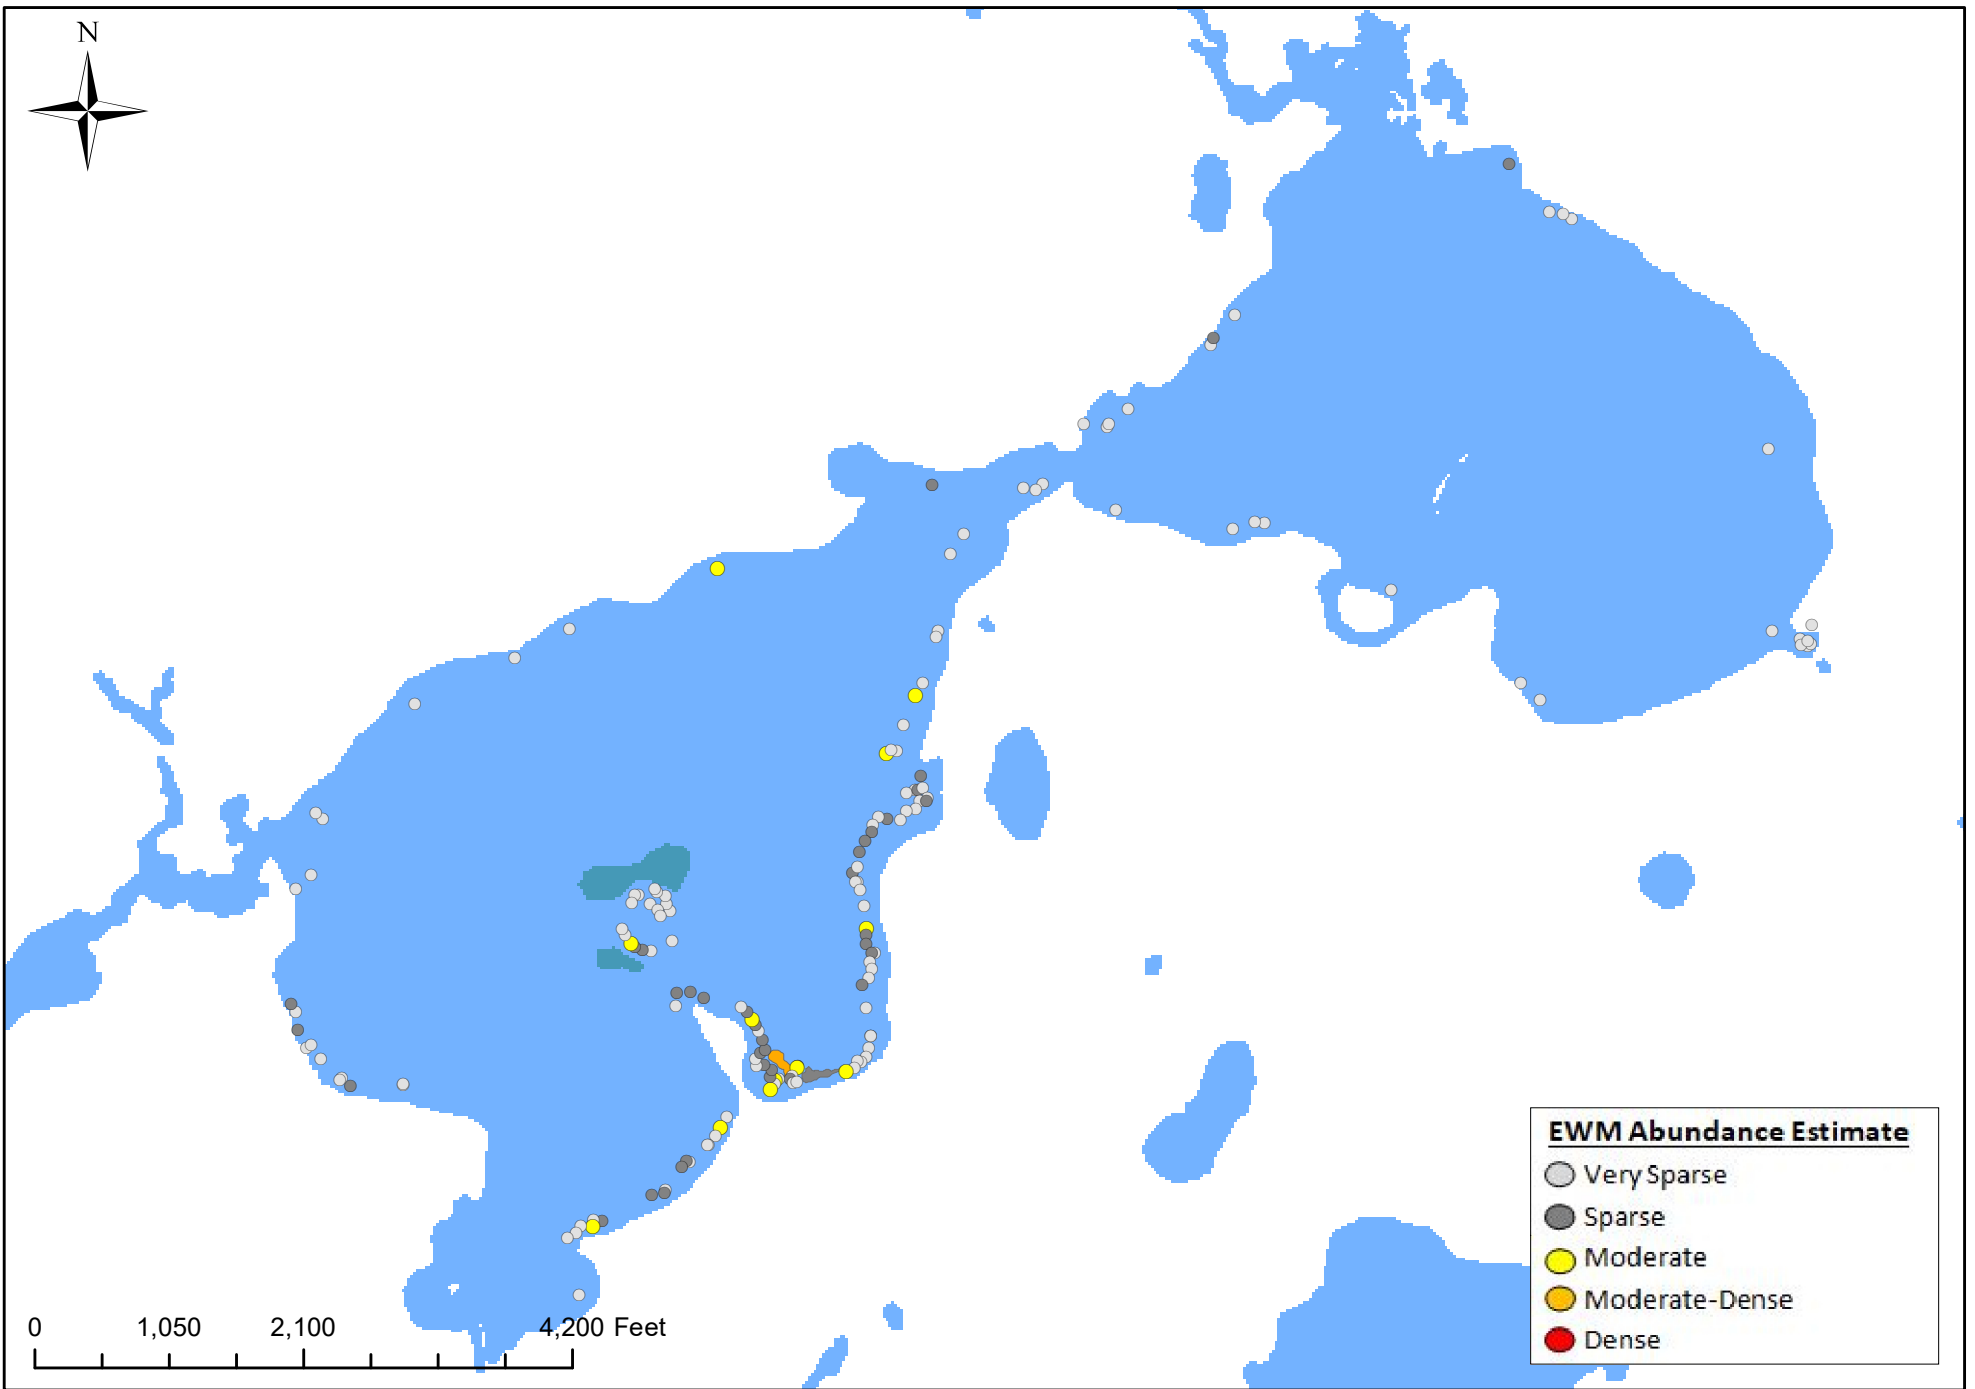
**Early Season EWM Survey
Upper and Lower Buckatabon Lakes
2019**

Early season monitoring took place on July 8th and focused on relocating existing EWM locations and high likelihood areas including boat launches, shallow bays and regions adjacent to known locations. Populations of EWM within the general regions of previous known sites grew in size and density since the end of the 2018, with highest abundances found in Upper Buckatabon. Multiple new locations of EWM found on Lower Buckatabon consisted of sparse to very sparse colonies. Mid/Late season EWM monitoring took place on September 28th detecting EWM in the general locations already known to exist on Upper and numerous new locations on Lower Buckatabon Lakes.

Lake: Upper and Lower Buckatabon, Vilas County, WI
Map Date & Creator: 8.13.19, updated 3.18.20, Many Waters, LLC
Survey Date: 7.8.19
Source: WDNR hydro, EWM-Many Waters
File: Buckatabon_ES_2019

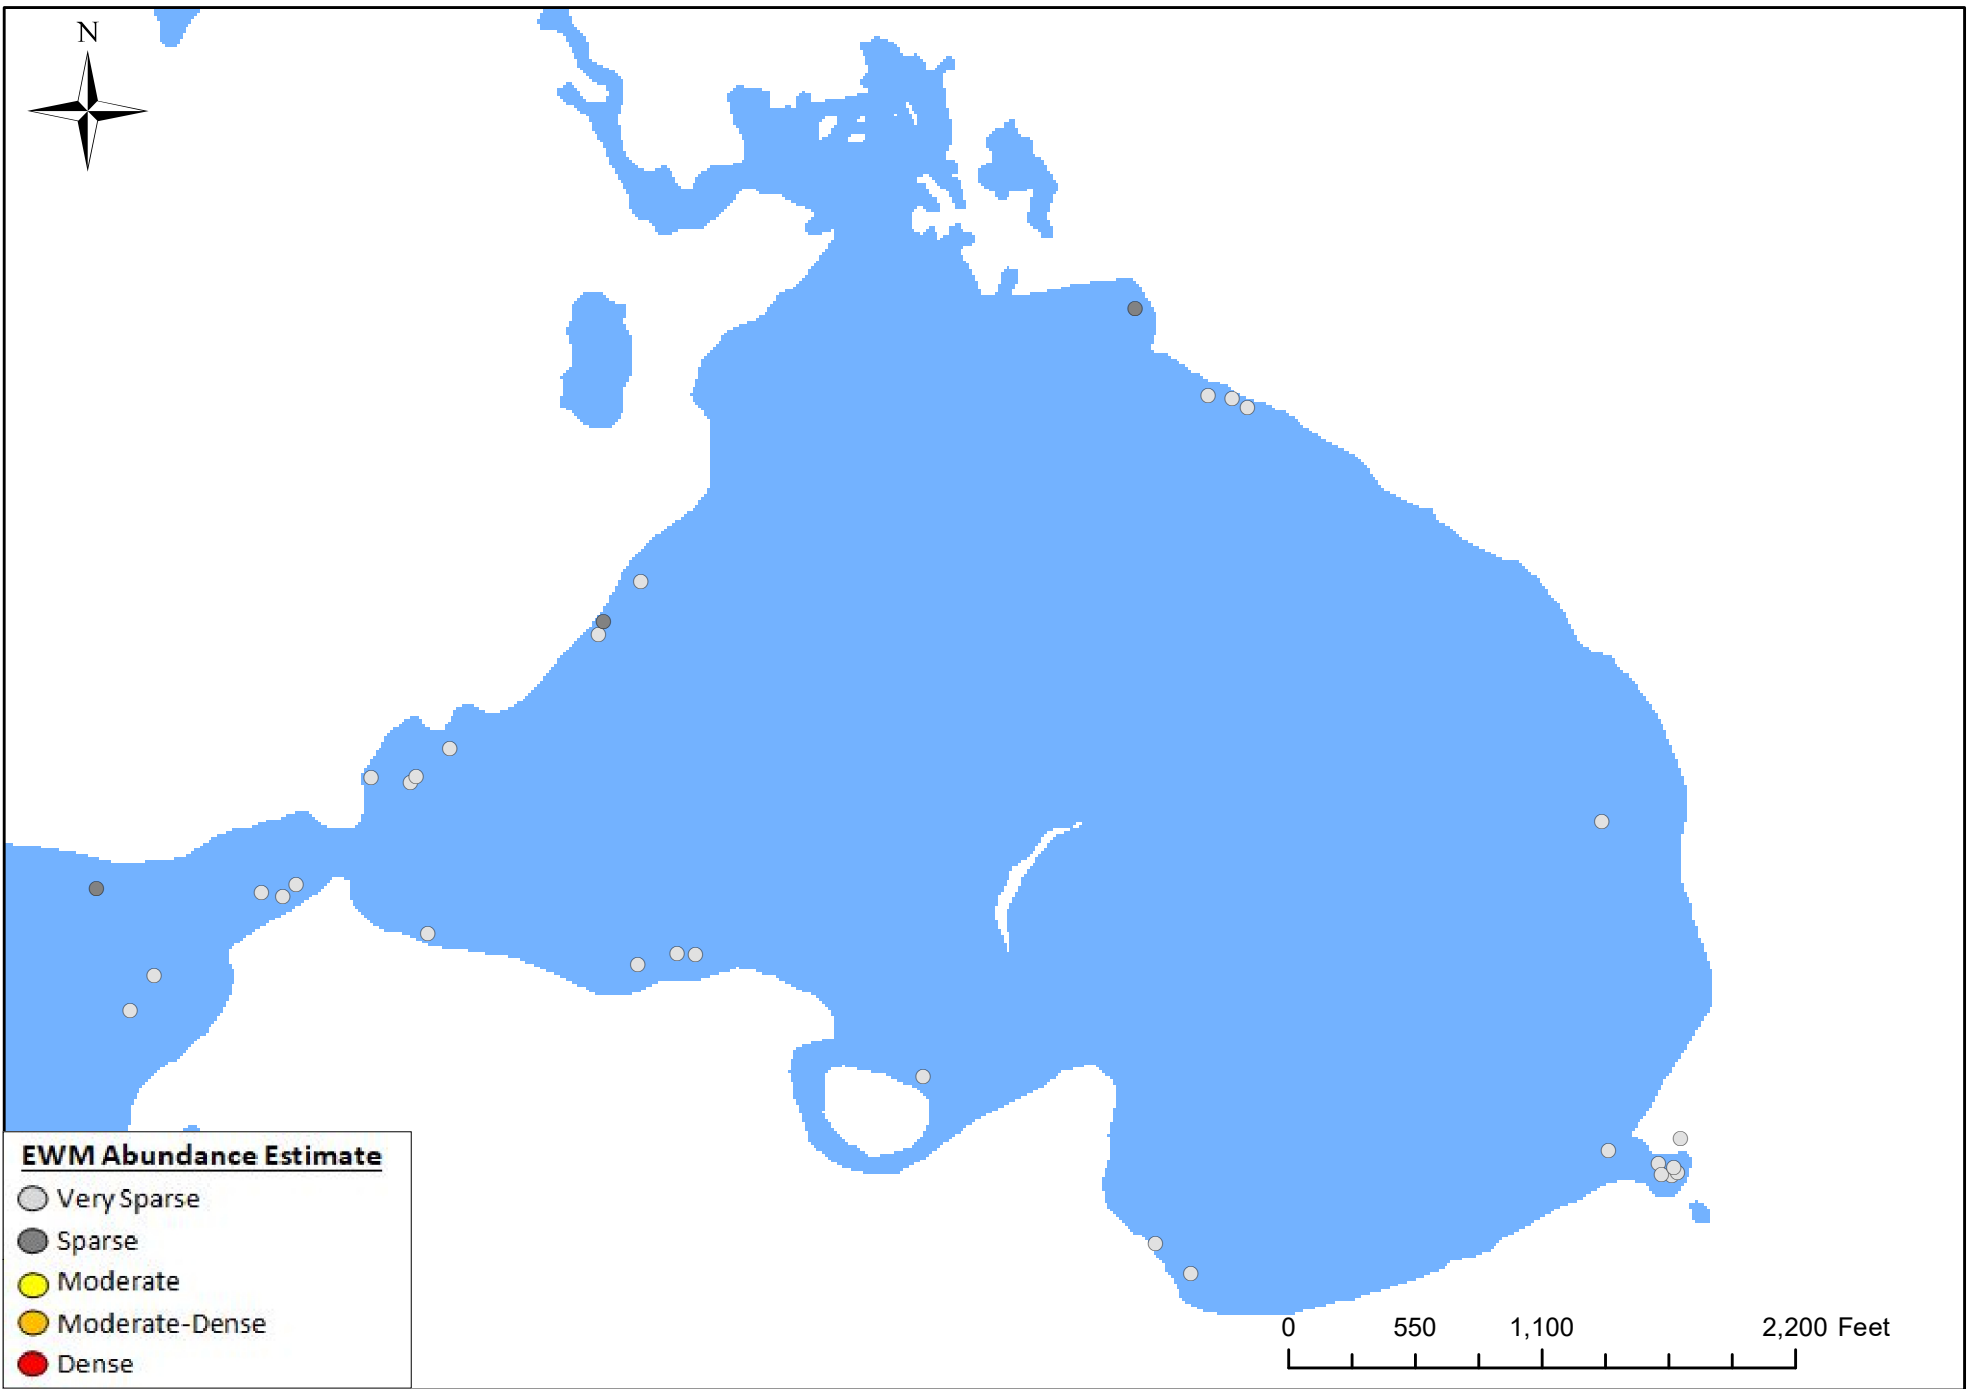
**Early Season EWM Survey
 Lower Buckatabon
 2019**

Lake: Lower Buckatabon, Vilas County, WI
 Map Date & Creator: 8.13.19, updated 3.18.20, Many Waters, LLC
 Survey Date: 7.8.19
 Source: WDNR hydro, EWM-Many Waters
 File: Buckatabon_ES_2019

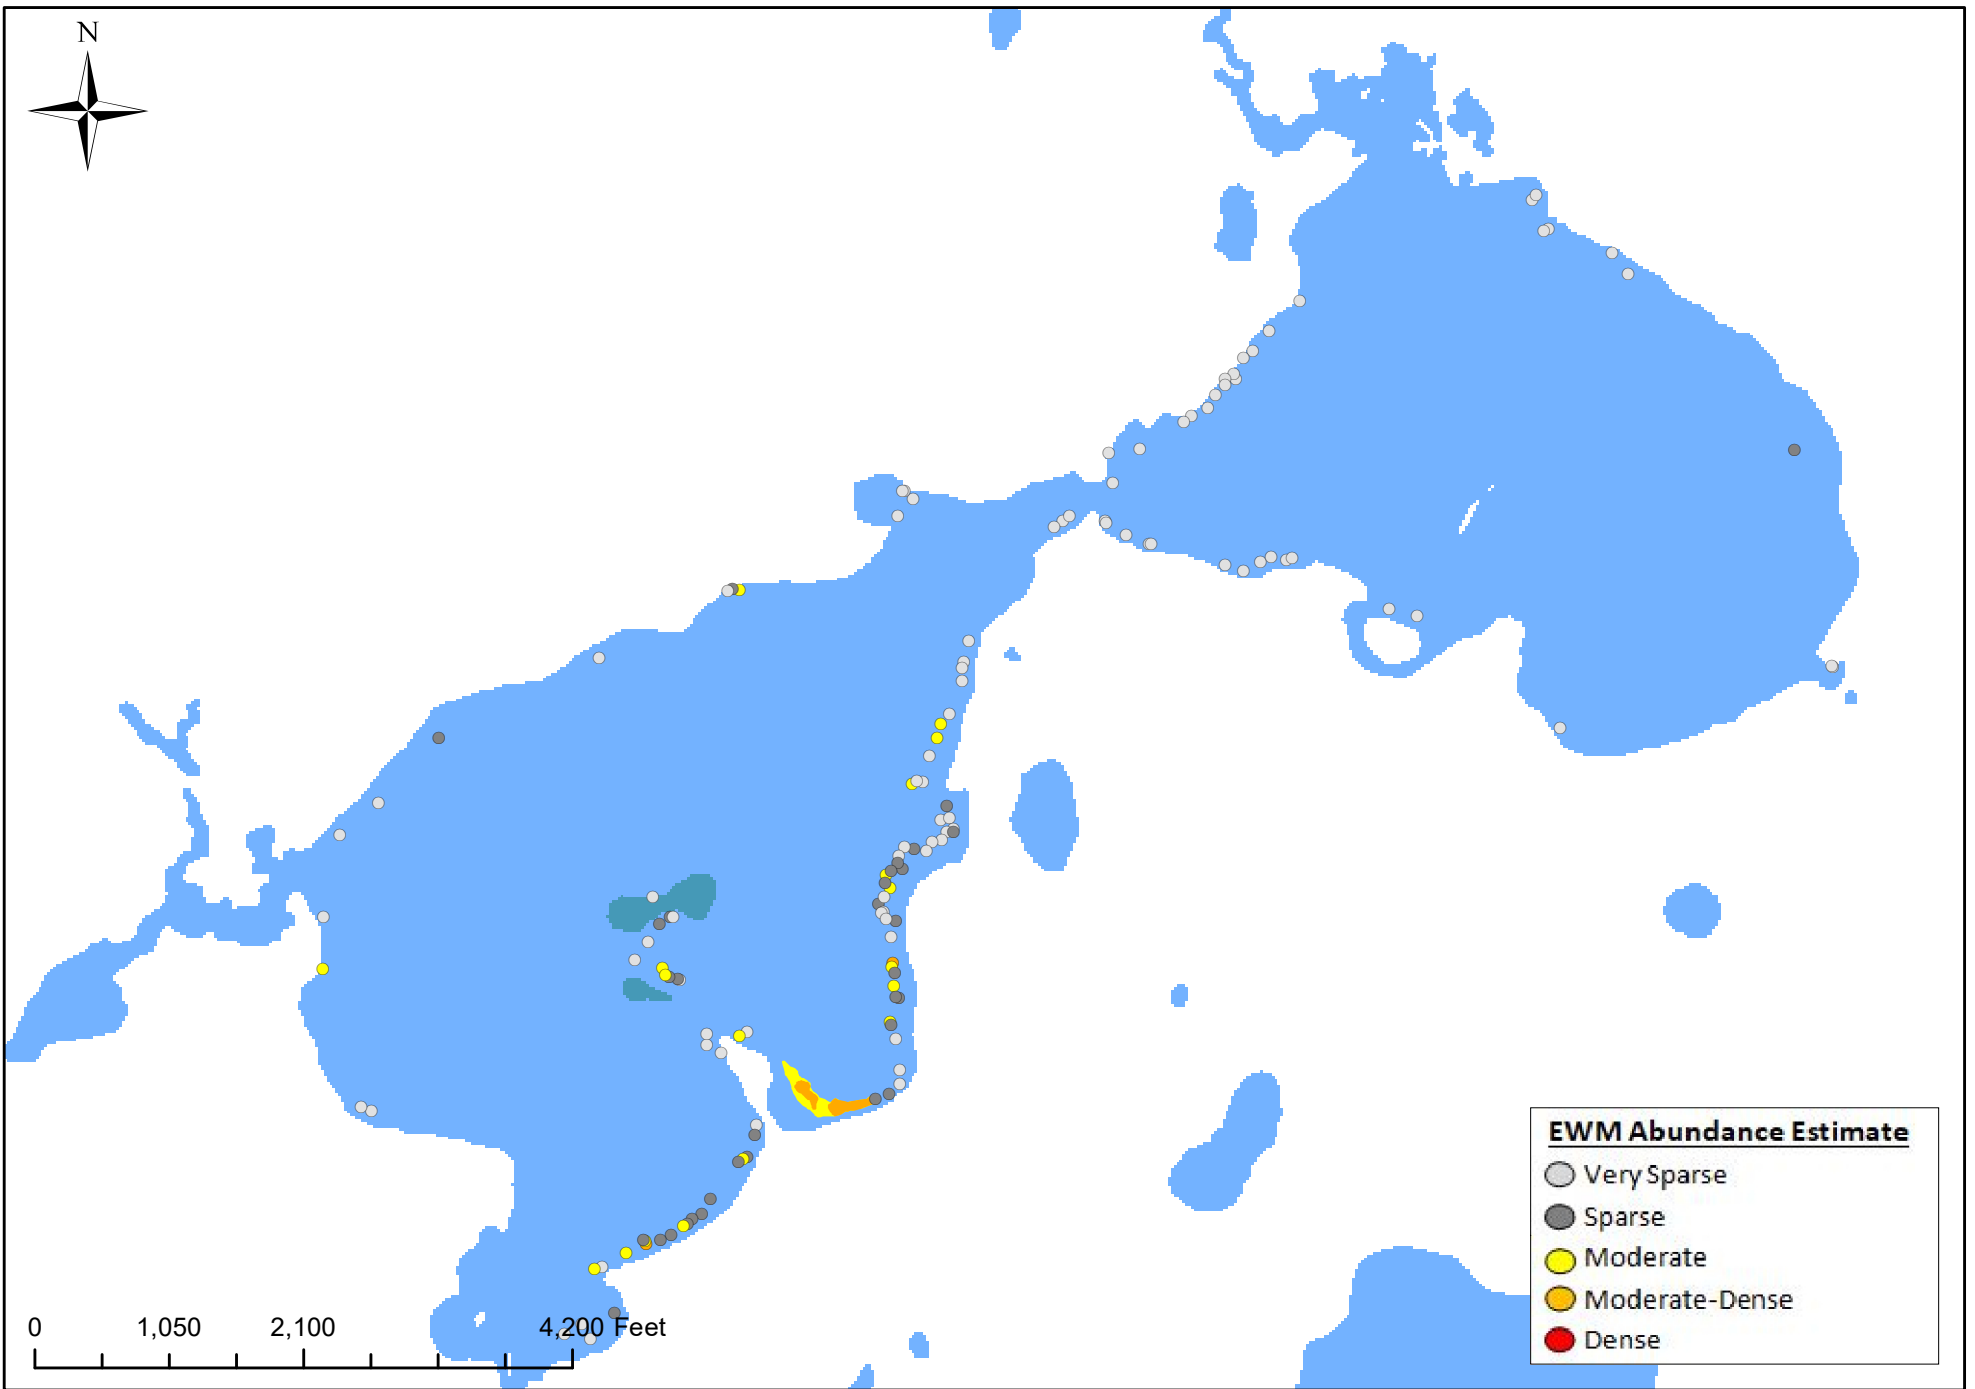
**Mid/Late Season EWM Survey
Upper and Lower Buckatabon Lakes
2019**

Lake: Upper and Lower Buckatabon, Vilas County, WI
Map Date & Creator: 3.18.20, Many Waters, LLC
Survey Date: 9.28.2019
Source: WDNR hydro, EWM-Many Waters
File: Buckatabon_ES_2019

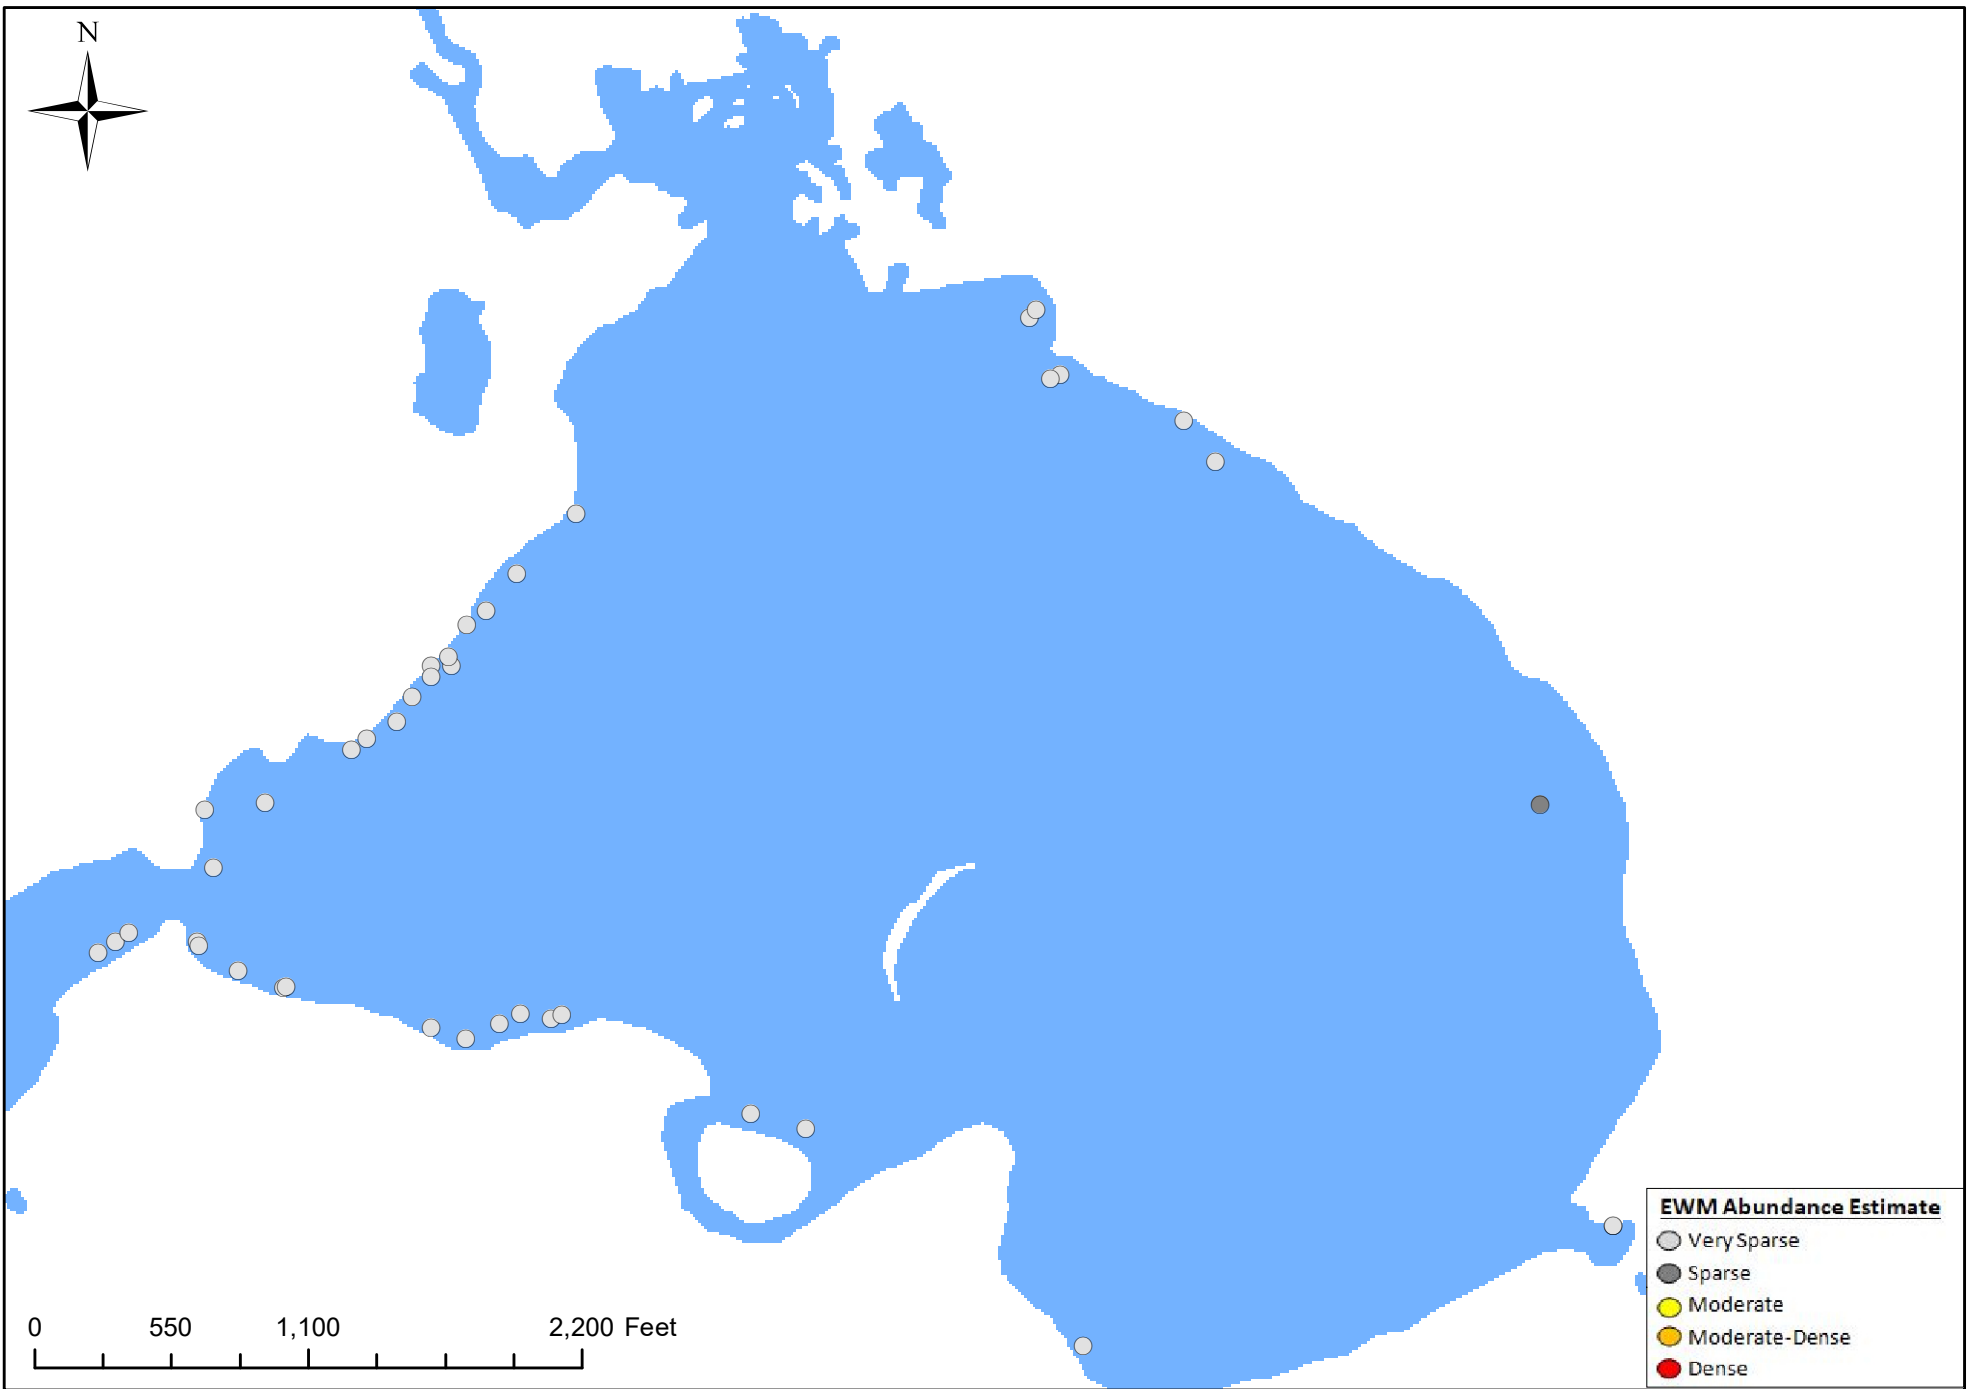
**Lower Buckatabon Lake
Mid/Late Season EWM Survey
2019**

Lake: Lower Buckatabon, Vilas County, WI
Map Date & Creator: 3.18.20, Many Waters, LLC
Survey Date: 9.28.2019
Source: WDNR hydro, EWM-Many Waters
File: Buckatabon_MLSS_EOY_2019

Due to the expansion of EWM across Upper Buckatabon and several new locations of EWM found in Lower Buckatabon, EWM management sought to reduce distribution (foot-print) of EWM rather than overall abundance. The approach included hand removing all EWM locations on Lower Buckatabon and emphasizing low density and regionally isolated sites on Upper Buckatabon. The distribution reduction rationale was to target these smaller less dense sites before they could potentially expand and reduce lake-wide footprint. This meant that no DASH work was performed in 2019. Given the current status of EWM of Upper Buckatabon, DASH efforts may have reduced EWM abundance at very localized level, but would have done very little to reduce lake-wide abundance or foot-print.

All known locations based on the early season mapping were dove on Lower Buckatabon. In total divers removed 200 plants weighing 30 pounds (wet weight). Dive efforts focused on isolated locations of EWM on Upper Buckatabon starting north of the boat launch working clock-wise around the lake to the first moderate colony found just south of the entrance to the springs. In total divers removed 67 plants weighing 14 pounds (wet weight).

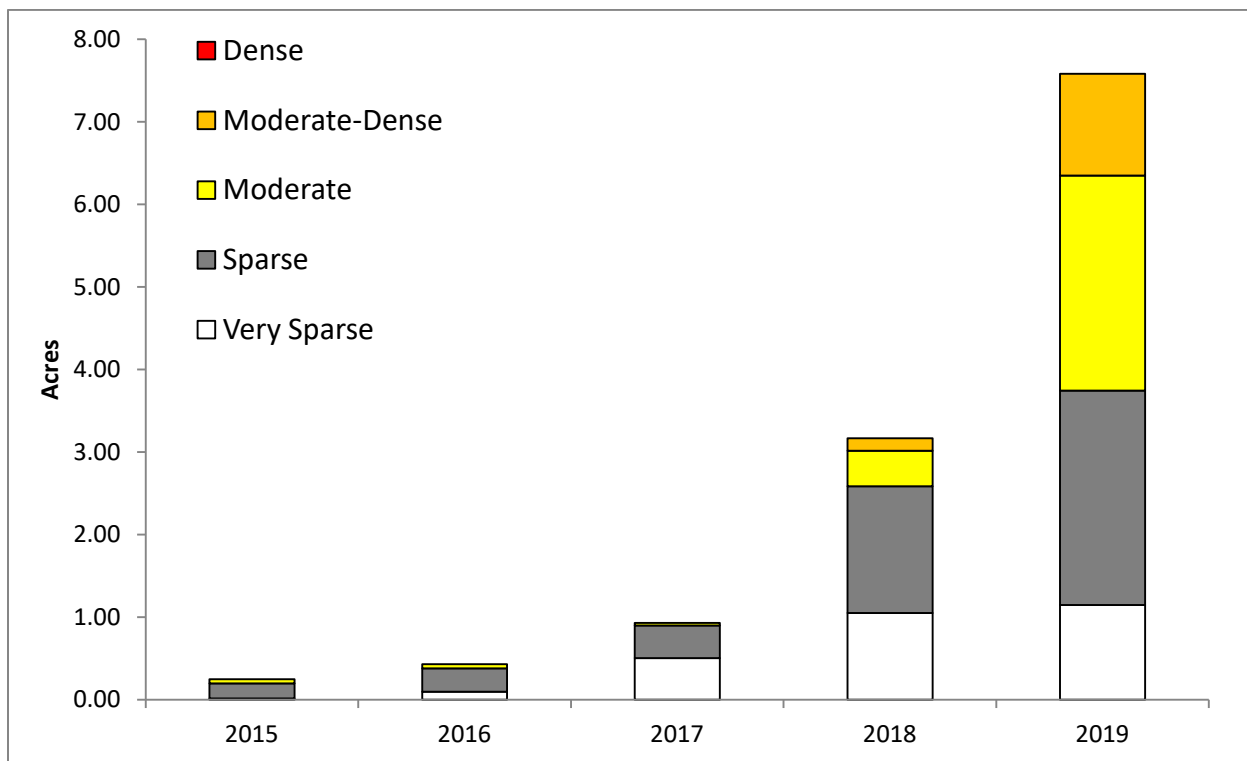
Figure 1: Change in EWM acreage (point based and polygon based mapping combined) categorized by estimated abundance 2015-2019 – Upper and Lower Buckatabon Lakes Combined.

EWM Abundance Estimate	2015	2016	2017	2018	2019
Very Sparse	0.02	0.10	0.50	1.05	1.15
Sparse	0.18	0.28	0.40	1.54	2.60
Moderate	0.05	0.05	0.03	0.43	2.61
Moderate-Dense	0.00	0.00	0.00	0.15	1.23
Dense	0.00	0.00	0.00	0.00	0.00
TOTALS (acres)	0.25	0.43	0.93	3.17	7.58
