# OHIO RIVER STEUBENVILLE MARINA

**FEASABILITY REPORT**

JUNE 17, 2024

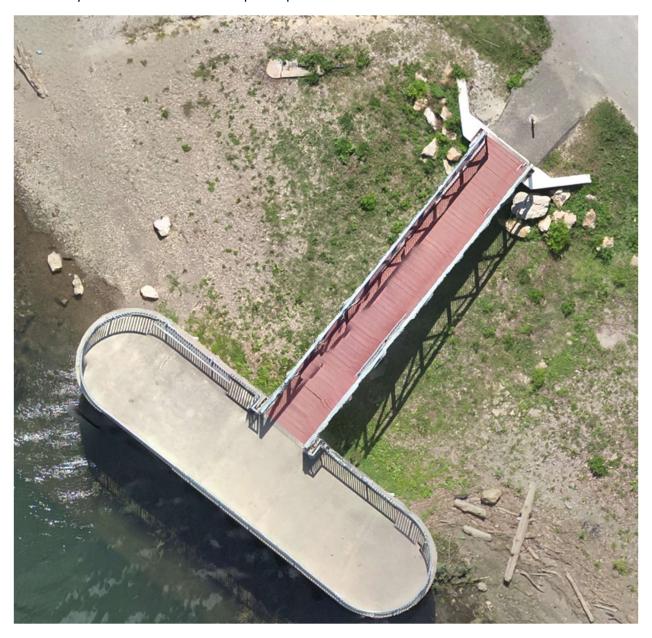
Figure 4 – Existing Pier

Significantly, remnants of a previously employed boat lock are present on the site. The proposed improvements work within the existing limits created by the existing river wall. The full structural condition of the existing river wall is unknown and future investigation would be needed to address structural integrity. Anything beyond external visual inspection of the sea wall integrity lies outside the scope of this report. As part of this investigation an initial aerial survey was performed using drone photography. This imagery is included as part of this report and can be referenced for the sea wall conditions. Based on the visual inspection, it was determined the structure is suitable to support the outlined work. In the event that this project moves forward, it is recommended to have a thorough structural evaluation of the sea wall. Moreover, the evaluation has identified the existing picnic shelter houses as potential candidates for replacement. Another observation is that the existing pier is in satisfactory condition and does not require replacement.

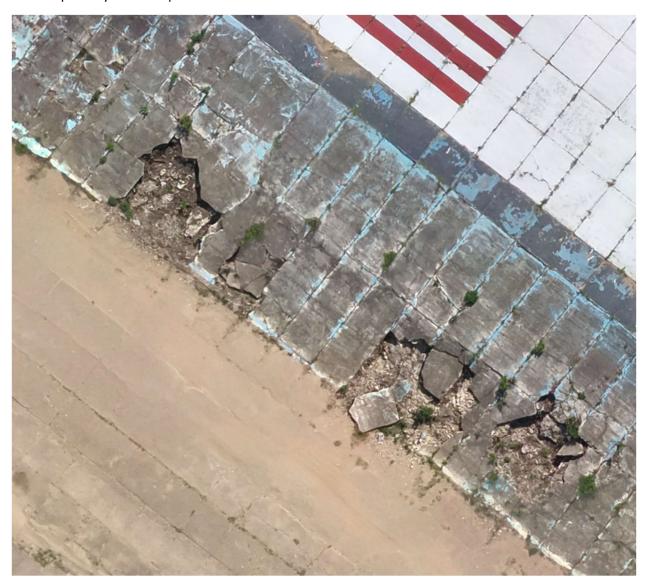
Figure 5 – Existing Revetment

Additionally, it is noteworthy that the existing revetment, while currently serving its purpose, is in poor visual condition, with sections visibly crumbling (Figure 5). This visual deterioration signals the need for attention and potential rehabilitation to maintain the structural integrity and aesthetic quality of the site. The recommendation at minimum is to replace at least 30% of the existing revetment with new panels. Ideally if funding allows the revetment could be replaced with a more functional furnishing such as building in amphitheater seating or replacing with a retaining wall. Some options of which have been outlined as part of this report. As part of this project examination, it was determined that Division of Wildlife will not contribute financially to the park infrastructure, of which this revetment is considered. Costs related to park infrastructure will fall under City of Steubenville, and these expenses have been listed separately at the request of ODNR.

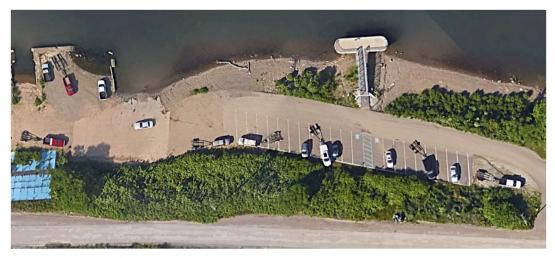
Figure 6 - Existing Parking

The ramp is currently accessible via an existing gravel access drive that transitions into a concrete drive and parking area. However, the existing parking area striping falls short in length. This inadequacy leads to vehicles with trailers parking at awkward angles to avoid obstructing traffic flow as seen in Figure 6. The current site parking striping consists of 19 standard spaces and two ADA parking spaces.

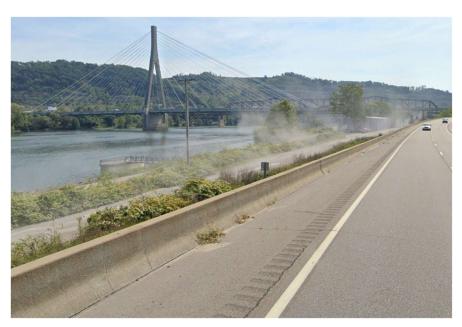
Figure 7 – Road Dust

A notable issue identified is the substantial amount of dust resulting from traffic traveling on the gravel sections of the access roadway, as illustrated in Figure 7. This dust generation presents an inconvenience and visitor complaints raised the need for mitigation measures.

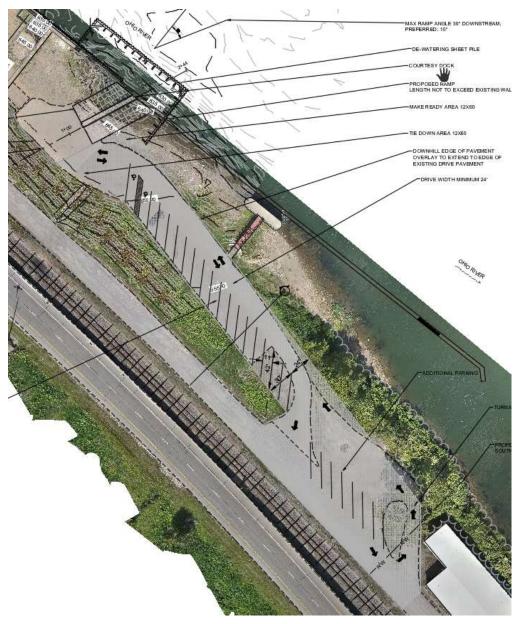
Figure 8 – Option 1

The proposed boat ramp outlined in this report signifies the minimum improvements necessary to provide a boat ramp, ensuring ample maneuvering space for a 19' long vehicle towing a trailer measuring 26' long and 8.5' wide, consistent with the standard design dimensions for Ohio boating facilities. Notably, the existing ramp falls short of meeting the minimum slope requirements outlined in the boating manual, posing unnecessary challenges for boaters attempting to access and utilize the ramp. To address this, the initial plan offers a proposed ramp which meets the requirements laid out in the boating design manual. This proposed ramp meets the requirements for being a two-lane launch ramp. At the request of DNR, the proposed two-lane launch ramp was designed to integrate a fixed concrete courtesy dock.

Option 1 is considered the minimum work required to improve the site, including replacing the existing boat ramp, adjusting the existing paving limits, and restriping the southern parking lot. In addition, the existing lock north of the ramp is to be filled in and paved, and a minimum of 30% of the existing failing revetment is to be removed and replaced.

The constraining factor in implementing a two-lane launch ramp is parking and make-ready / tie-down requirements as laid out in the boating facility guidelines. The minimum number of parking spaces needed to install a two-lane ramp is 30. Option 1 alone provides 25 parking spaces. This does not meet the minimum requirements for a two-lane ramp. As such, Option 1 is intended to be partnered with another Option outlined in this report that increases the parking count to meet or exceed the minimum of 30 parking spaces recommended. If this parking count is not achieved, the proposed ramp will have to be redesigned as a one lane launch ramp, per the guidelines set forth in the Ohio Boating Facilities Standards Manual.

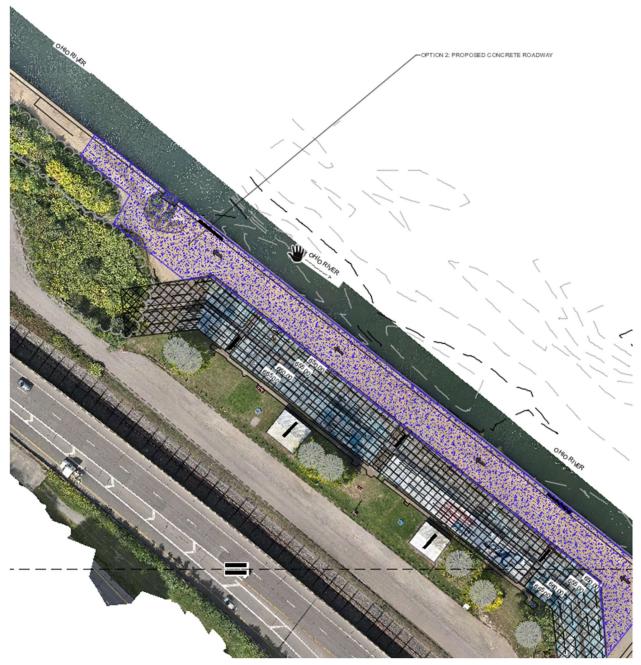
Figure 10 – Option 2

The scope of work for this option is limited to paving the lower drive section from the extents of paving of option 1, up to the northern parking lot connection. This option would be beneficial for improving the overall site conditions and flow of traffic to the site. The existing pavement is currently in satisfactory condition and this option can be reserved for future consideration.

The primary disadvantage of this option is the additional cost, and the lack of immediacy in needing to repave this section of the site.

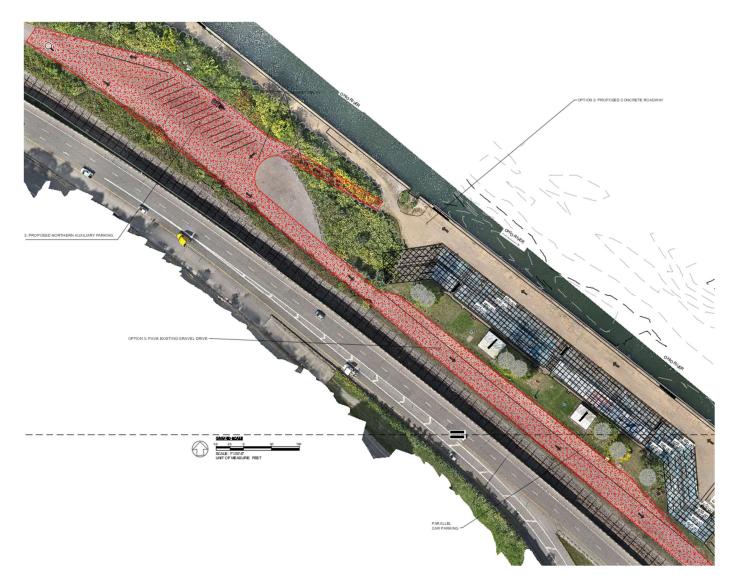
Figure 11 – Option 3

Option 3 focuses on maximizing the site with improvements to the upper lot and access drive. Through the addition of a ramp at the north end of the property a connecting "loop" is created between the upper and lower sections of the Park. The result enhances the experience for both boaters and visitors while ensuring optimal access to all areas. Combining this option with option 2 offers a comprehensive solution, providing boaters with expanded maneuvering and parking options.

The paved northern parking spaces not only improve the overall Park appearance but also offers ample vehicle parking, providing convenient pedestrian access to the nearby picnic shelters.

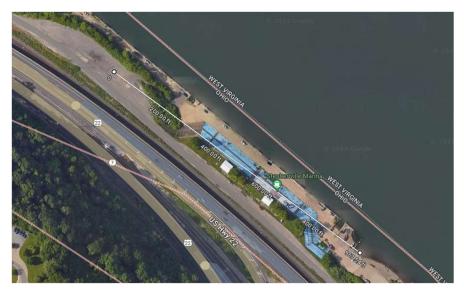
Travel distance from the northern car park to the proposed ramp, was reviewed and highlighted in figures 12-14. These dimensions compare the straight-line distance from this proposed northern parking lot to the furthest parking spaces at existing ODNR facilities. As confirmed in these exhibits the distance from the northern parking area is comparable to that of other ODNR facilities.

Figure 12 – Proposed Parking Distance: 967'

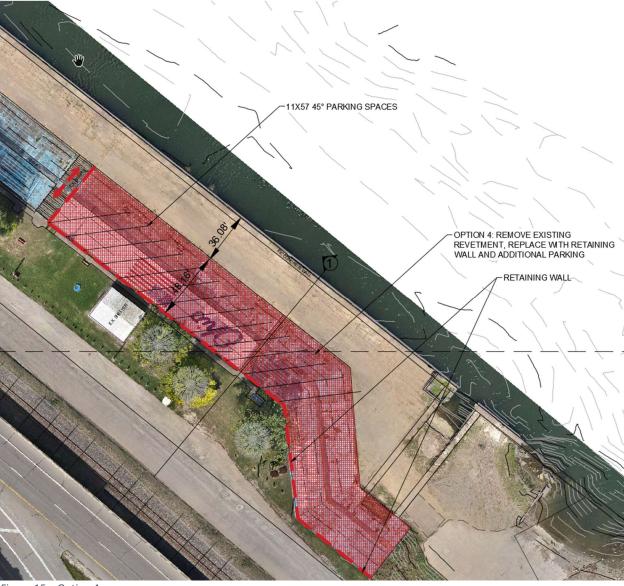
Figure 15 – Option 4

To address the failing existing revetment, and increase the parking count, option 4 represents the removal of the failing revetment, replacing with a retaining wall. This reclaimed area would provide an additional 13 parking spaces and expand the turnaround area for the boat launch. This option is highly recommended as it will address two critical issues for the site providing much needed infrastructure improvements, however, the large investment will likely require long term budget planning.

Option 4 shows the removal of the southern section of existing revetment. This would be replaced with a retaining wall, facilitating the use of the reclaimed area as additional parking.

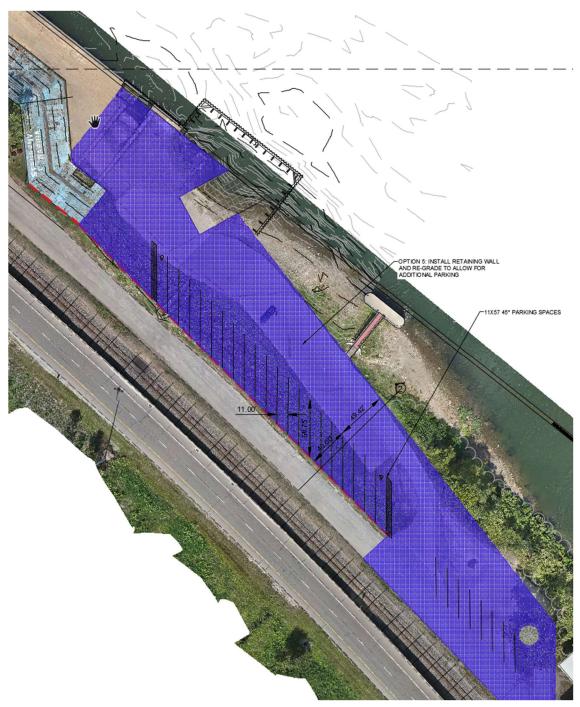
Figure 16 – Option 5

Option 5 is a reimagining of Option 1 with the addition of constructing a retaining wall to the south of the existing revetment. This retaining wall will allow for the site to be regraded even further. The area gained from regrading the site will be used to expand the drive lanes, increase parking, and expand the turnaround area. Ideally Options 4 and 5 can be implemented together, but if cost prohibitive, the two options can be completely independent of one another. Option 5 is the recommended, all-inclusive alternative approach which absorbs the scope of Option 1 along with the new wall.

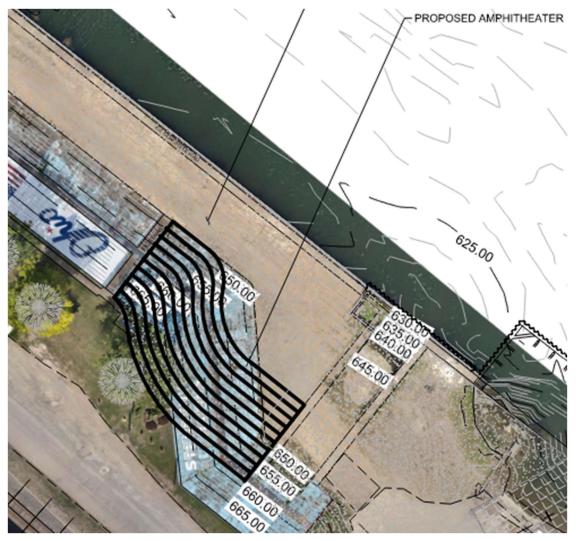
Figure 17 - Option 6

Option 6 focuses on the complete rehabilitation of existing shelters, stairs, and the revetment. This design envisions the reconstruction of the existing revetment. A notable enhancement in this proposal is the integration of amphitheater-style seating, creating an attractive, multipurpose event space for park visitors. This seating is positioned to allow spectators a view of the nearby bridge. This option is designed to not only improve infrastructure but also enhance the recreational and event capabilities of the park. In addition to the above site improvements, this option allows for an expanded boat ramp maneuvering area. Although this concept provides optimal improvements to the site, the extent of construction required appears to be cost prohibitive at this stage. This Option was determined to be not relevant to the current project scope but remains included as an example of future site enhancements for the City of Steubenville to consider.

Option 6, the replacement of existing revetment with amphitheater style seating, was included as an example of future enhancements to the site. This would further rehabilitate the failing revetment, while providing a usable feature. As part of the development of this report it was determined that this option will not be pursued as a part of this ODNR initiative, but remains included for reference should the city be interested in further site development.
