**Geotechnical Investigation
Park View Villas
1350 West 12600 South
Riverton, UT**

GeoStrata Job No. 1012-006

August 3, 2015

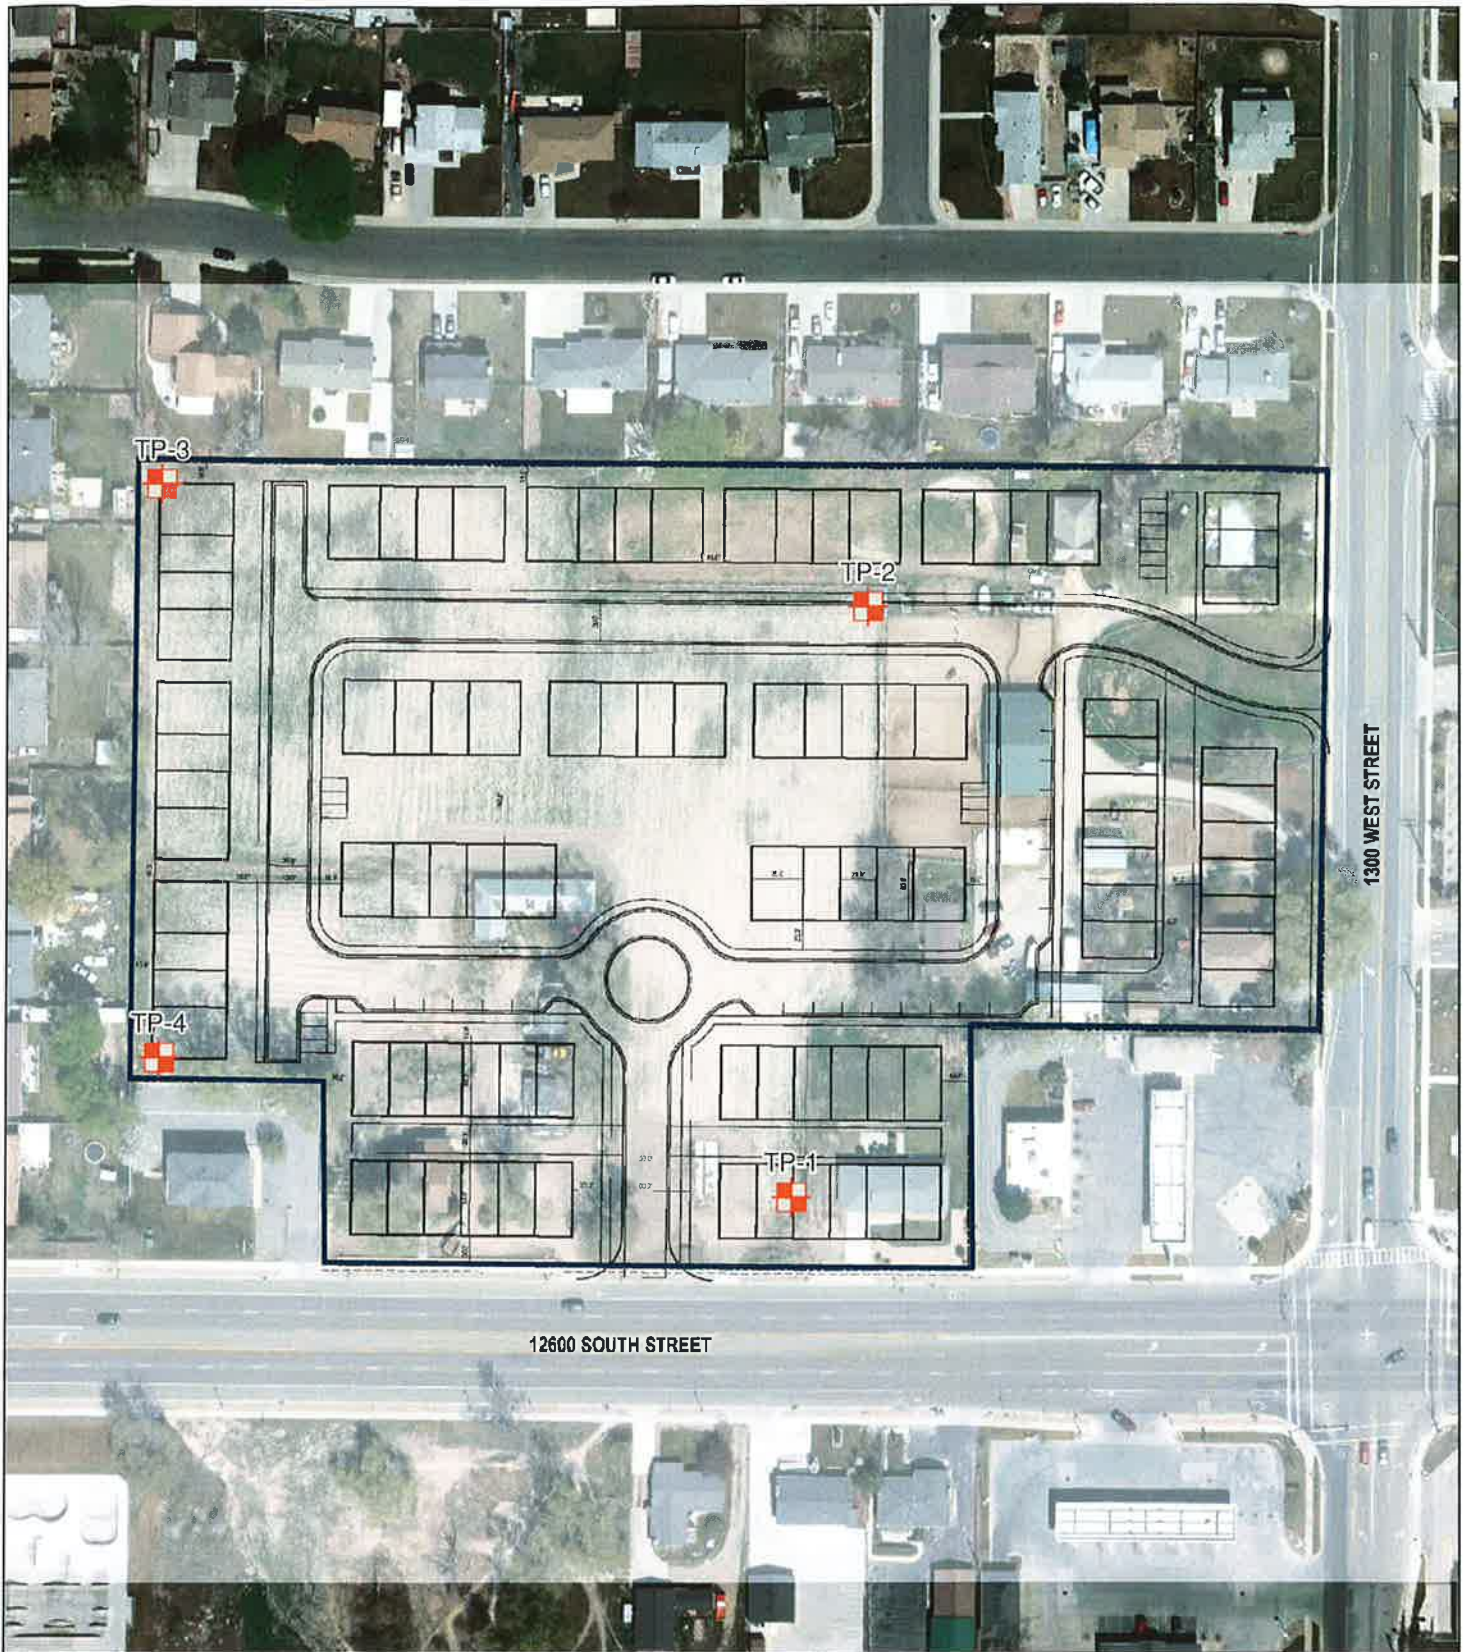
As a part of this investigation, subsurface soil conditions were explored by excavating four test pits to depths of 10 to 10½ feet below existing site grade. The approximate locations of the explorations are shown on the *Exploration Location Map*, Plate A-2 in Appendix A. Subsurface soil conditions as encountered in the explorations were logged at the time of our investigation by a geotechnical engineer and are presented on the enclosed Test Pit Logs, Plates B-1 and B-4 in Appendix B. A *Key to Soil Symbols and Terminology* is presented on Plate B-5.

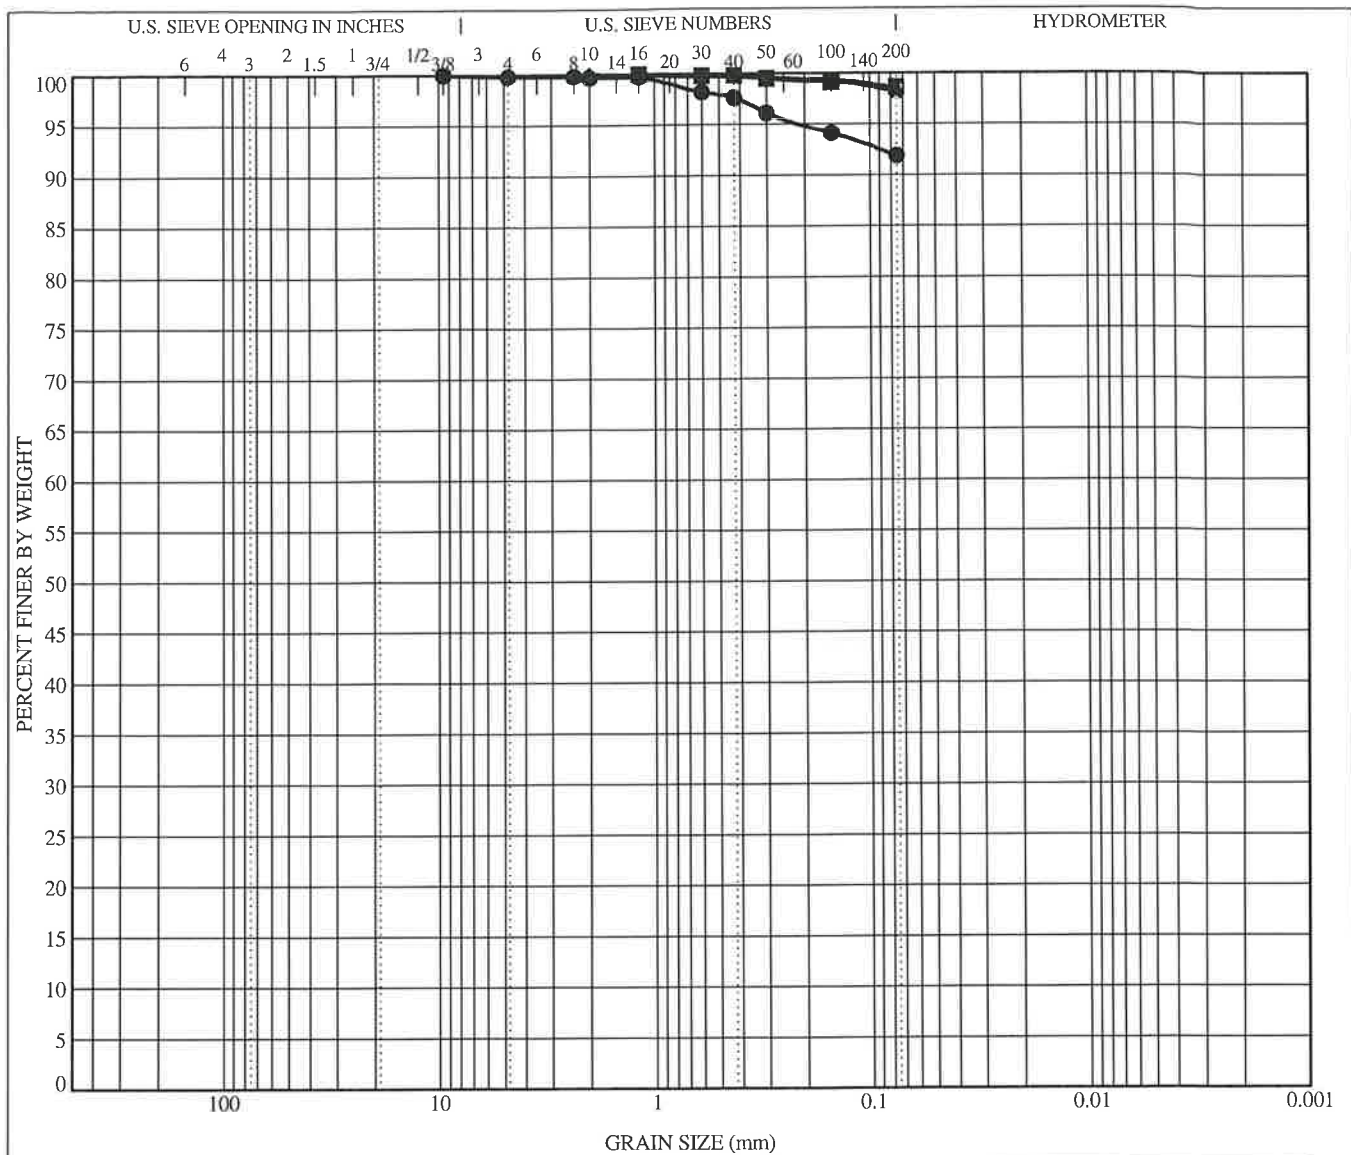
Plate
C - 3

COBBLES	GRAVEL		SAND			SILT OR CLAY
	coarse	fine	coarse	medium	fine

Sample Location	Depth	Classification	LL	PL	PI	Cc	Cu
● TP-1	2.5	Lean CLAY	32	19	13		
▣ TP-2	3.5	Lean CLAY	38	21	17		
▲ TP-3	9.0	Lean CLAY	35	20	15		
★ TP-4	8.0	Lean CLAY	37	20	17

The results of laboratory tests are presented on the test pit logs in Appendix B (Plates B-1 and B-4), the Lab Summary Report (Plate C-1) and on the test result plates presented in Appendix C (Plates C-2 through C-6).

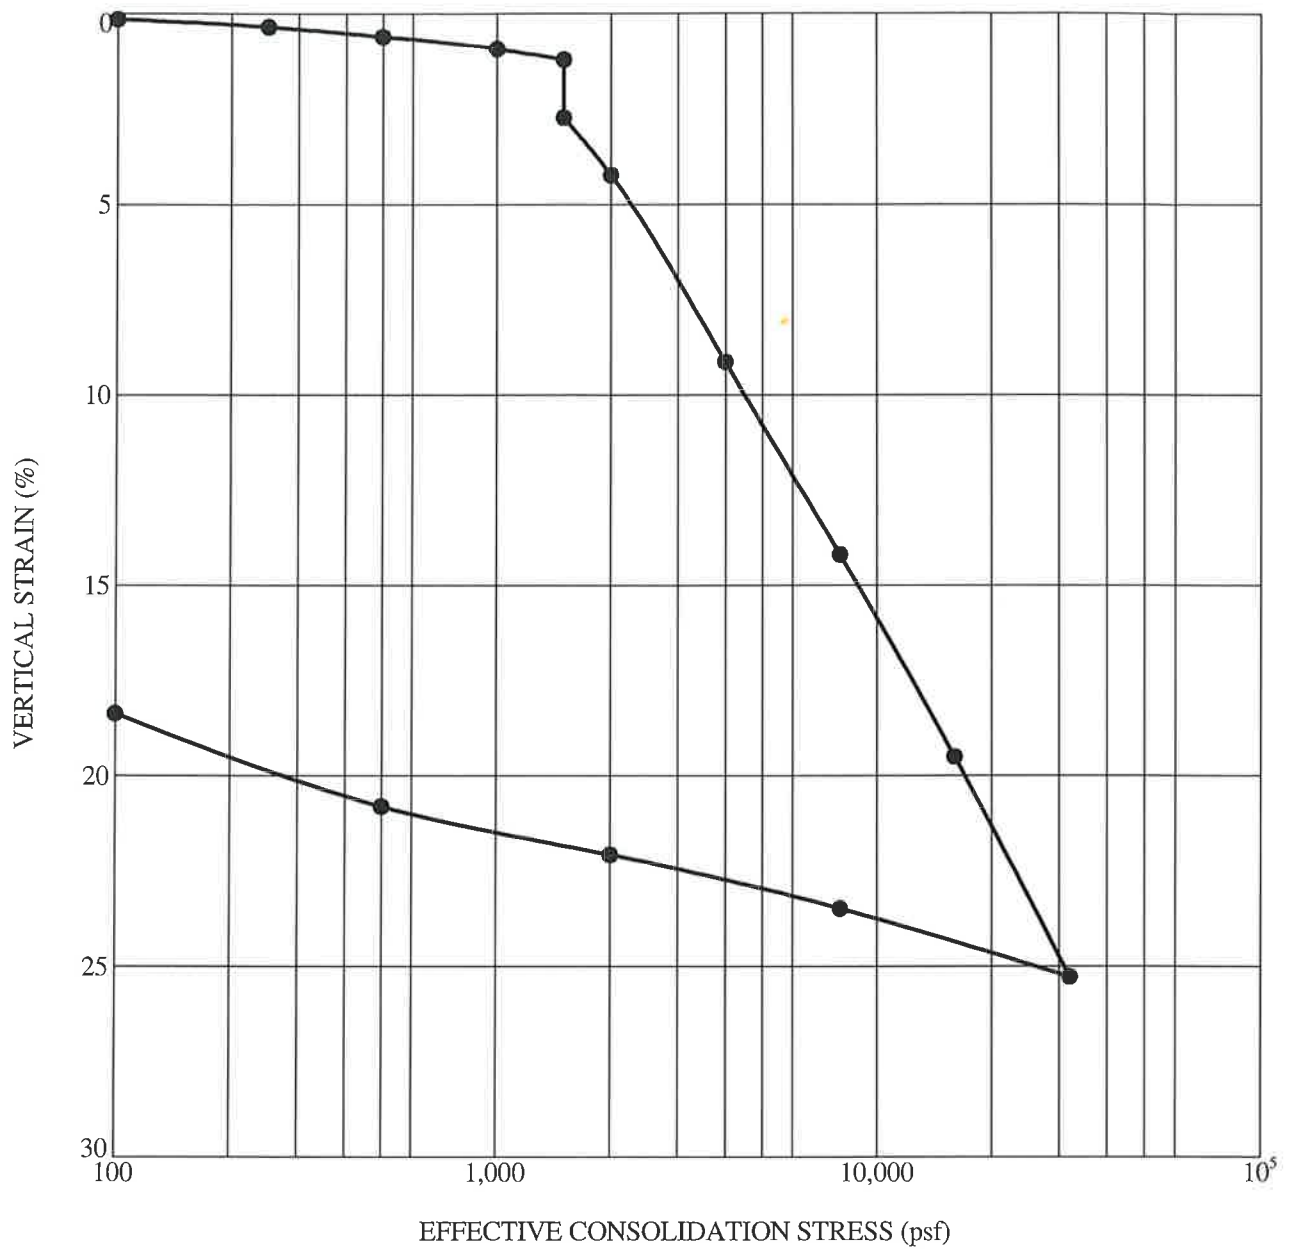
C - 4

Sample Location	Depth (ft)	Classification	γ_d (pcf)	MC (%)	C'_c	C'_r	OCR	Inundation Load (psf)	Swell (%)	Collapse (%)
● TP-2	3.5	Lean CLAY	79	13	0.172	0.027	4.8	1500	---	1.52
☒										
▲										
★										
◎
